# Structural Effect on Columns of Existing Low-Rise Buildings due to Installation of Rooftop Towers - A Case Study

F.M.M. Abdullah and A.M.L.N. Gunathilaka

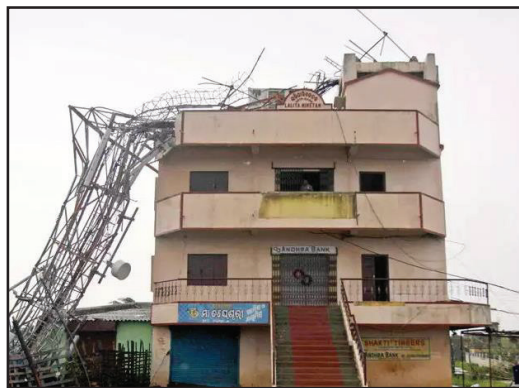
**Figure 1 - Failure of a Tower in Chennai in India during Cyclone Phailin in 2013 [2]**

Failures of rooftop towers causing damages to host structures have been reported especially in India in certain occasions. Figure 1 shows a failure of a rooftop tower causing damages to the host structure during cyclone Phailin in 2013 [2].

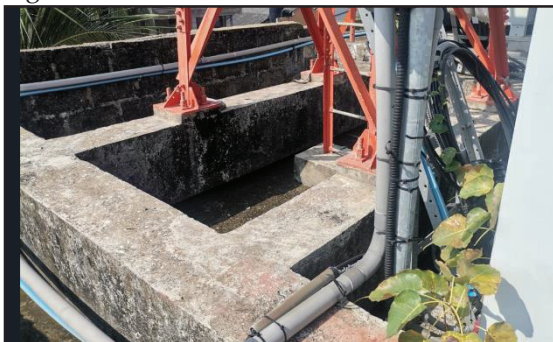
**Figure 2 - Structural Beam Arrangement of a Rooftop Tower**

Usually, self-supporting lattice towers are installed on a newly placed beam system on rooftops to ensure transferring additional stresses from rooftop towers directly to columns of host structures. Possibility of occurring drastic increases in stresses and possibility of occurring stress reversal with uplift forces from rooftop towers are the reasons for not installing rooftop towers on existing roof beams and slabs in general. Figure 2 shows a photograph of a typical beam system used on a rooftop in this regard.

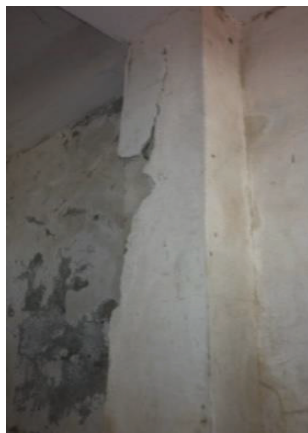
As per the results of the survey, visible cracks in columns were identified at 3 sites, and the worst affected site out of these sites was site no. 04. Clear visible cracks had been observed in certain columns between the 1st floor level and the roof slab level in this site. The photographs of observed cracks and a graphical representation of crack locations in 3D structural model of the building are shown in Figure 3 and Figure 4, respectively. A photograph of the tower at site 04 is shown in Figure 5. Any visible cracks were not observed in any other columns at this site.

(a) Cracks in the column at corner C4 column (Site No 04- 1<sup>st</sup> floor)

Therefore, combining the effects of cyclic overstressing in respective columns, and at lap joints of respective columns would lead to significant cracks observed above 1st floor in columns C3 and C4 at Site No. 4. Unfortunately, it was not able to perform any onsite testing of columns to further verify this, due to reluctance of site owners. Hence, urgent attention would be

required to repair these cracks in columns and strengthening of columns at that site (site no 04).

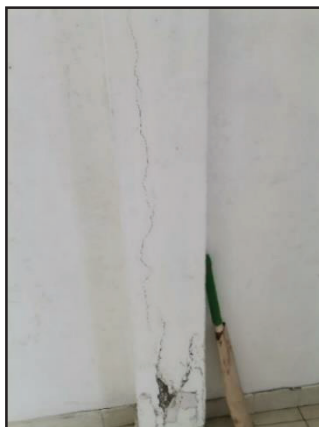
(b) Cracks in the column at C3 column (Site No 04- First Floor)
